EFFECTIVENESS OF ADDITIVES IN IMPROVING FUEL LUBRICITY AND PREVENTING PUMP FAILURE AT HIGH TEMPERATURE

**INTERIM REPORT
TFLRF No. 437**

**U.S. Army TARDEC Fuels and Lubricants Research Facility
Southwest Research Institute[®] (SwRI[®])
San Antonio, TX**

Contract No. W56HZV-09-C-0100 (WD0004–Task XVI)

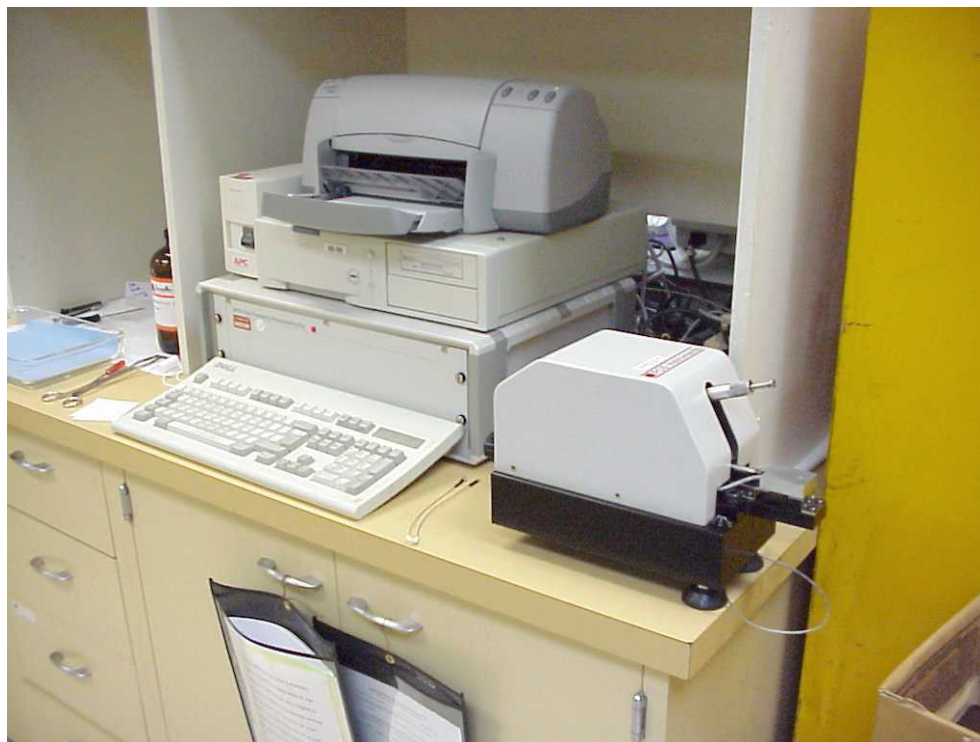
Figure 3. High Frequency Reciprocating Rig (HFRR)

BOCLE (Ball-On-Cylinder Lubricity Evaluation), SLWT (Scuffing Load Wear Test) also known as SLBOCLE, and HFRR (High Frequency Reciprocating Rig) analyses were performed at specific intervals throughout the testing sequences. The BOCLE tester is shown in Figure 1, the SLWT instrument is shown in Figure 2, and the HFRR tester is shown in Figure 3.

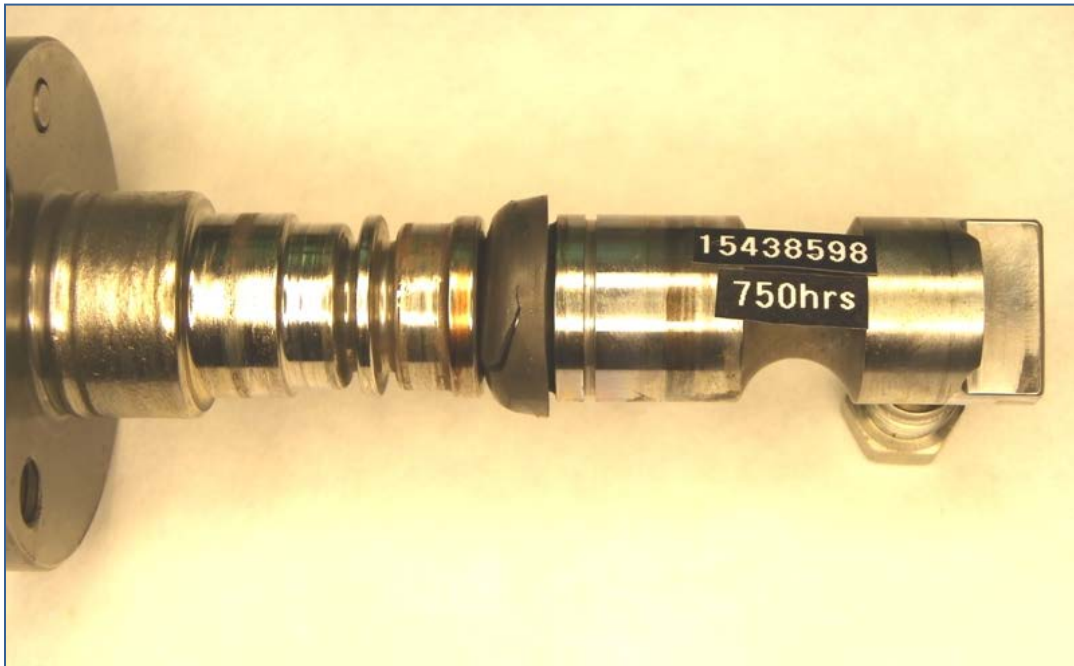
driveshaft assembly and the one remaining seal on pump No. 1. Figure 12 shows the pump body assembly with the damaged needle bearing race.

Figure 11. Drive Shaft Assembly Damage, Pump No. 1, Test 14

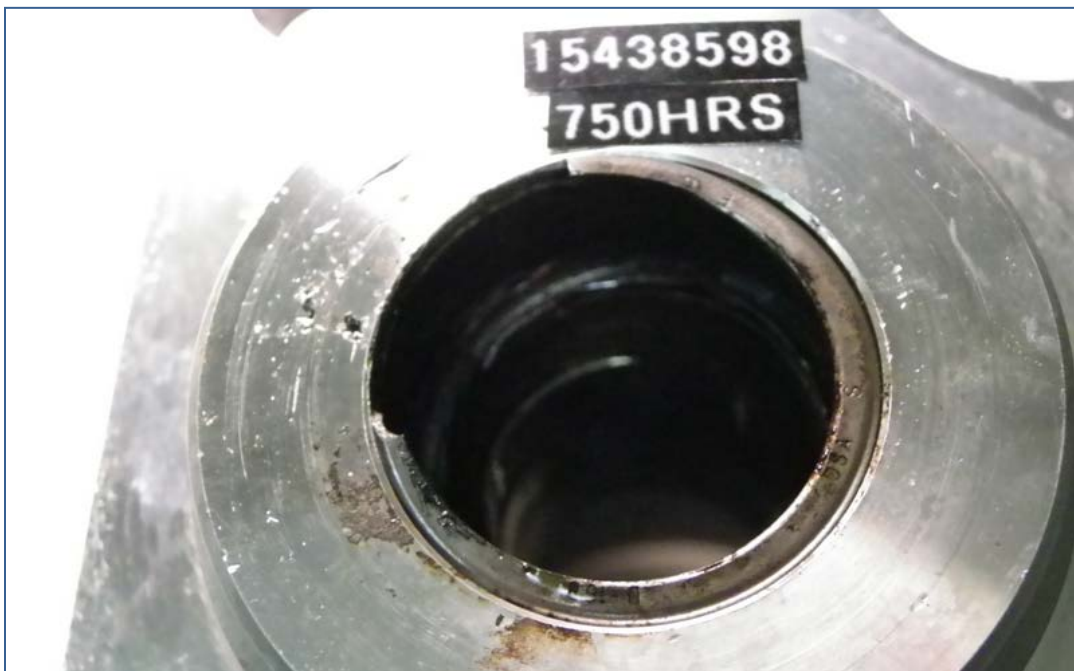
Figure 12. Housing Assembly Damage, Pump No.1, Test 14

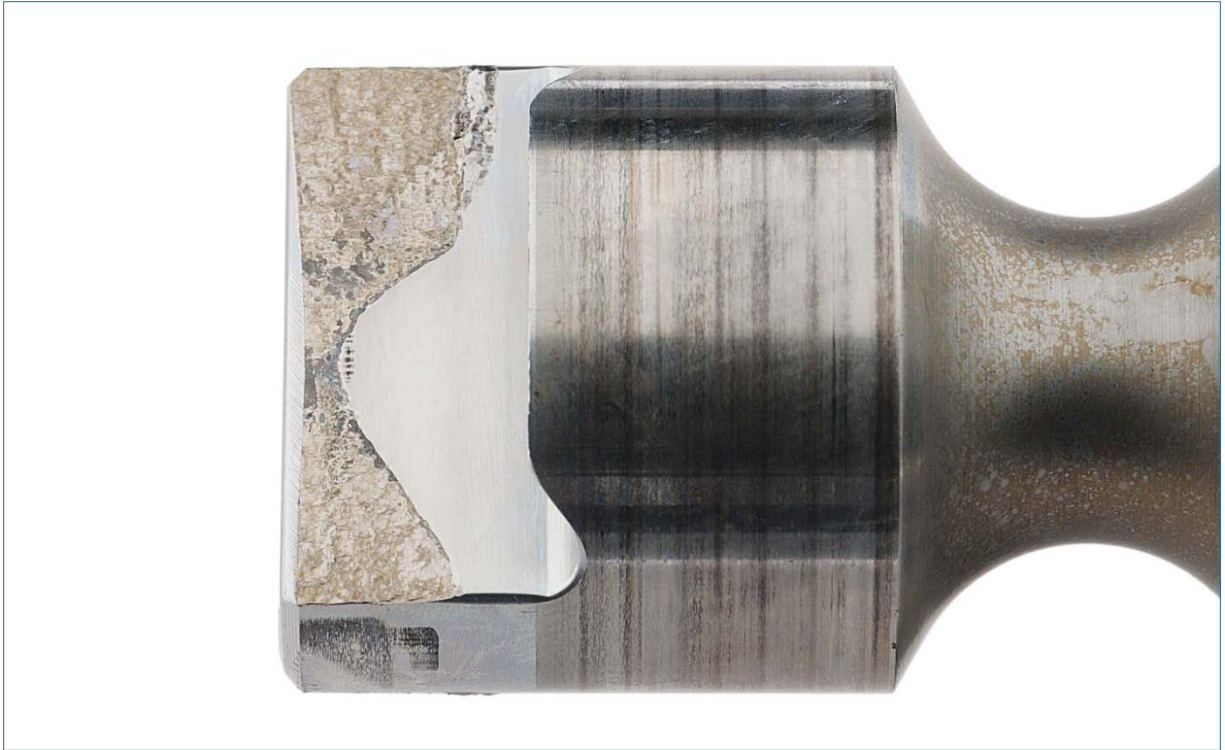
Figure 14. Heavy Drive Tang Wear, Pump No. 2, Test 21

Test 21 was conducted using a 50/50 blend of FT-SPK and Jet A-1 fuel additized with DCI-4A CI/LI at minimum concentration of 9 mg/L at temperatures of 170°F (77°C) for a targeted 1,000 pump stand hours. At 372 hours into the test, pump No.2 displayed a notable drop (approx) 25% in the fuel moving average. The test stand was shut down and the governor assembly top cover removed from the pump to inspect for excessive wear. Heavy metal shavings were seen in the solenoid assembly and the pump was removed from the stand to prevent rotor seizure. Test 21 was continued with the operational pump No. 1. The test stand was stopped at 418 hours into the test when the remaining pump became very noisy due to drive tang wear and the fuel moving average had dropped significantly. Figure 13 presents the governor assembly from Pump No. 1 showing heavy wear debris on the linkages. Figure 14 reveals excessive heavy drive tang wear, the associated heavy rotor drive slot wear for Pump No.2 is shown in Figure 15, and the rotor governor weight cage drive plate wear and fractures are seen in Figure 16.

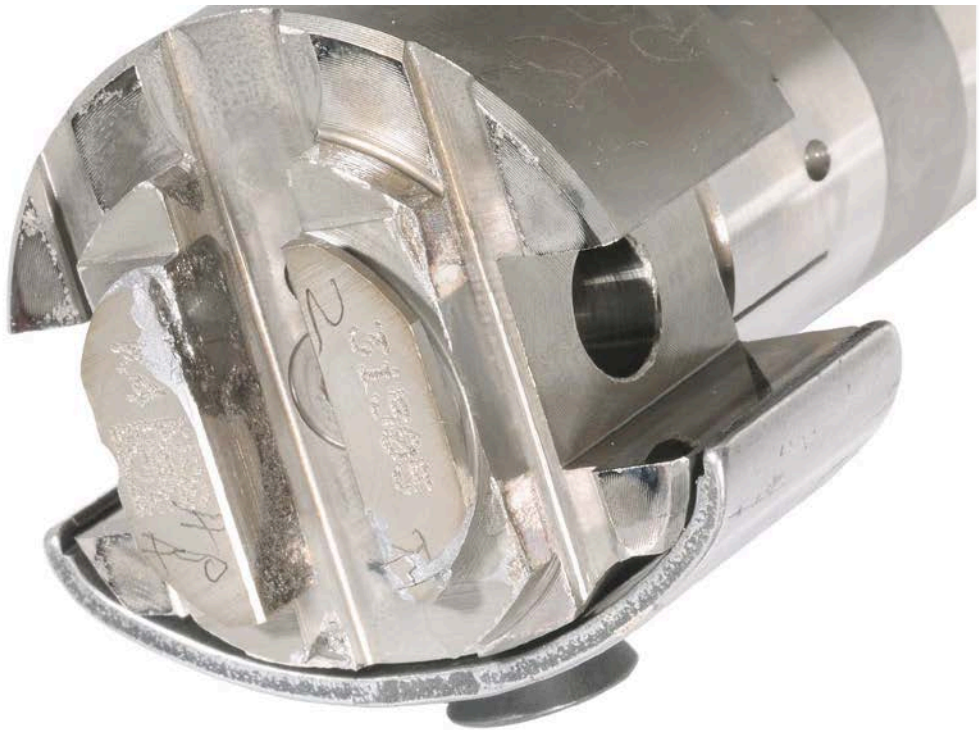
Figure 15. Rotor Drive Slot Heavy Wear, Pump No. 2, Test 21

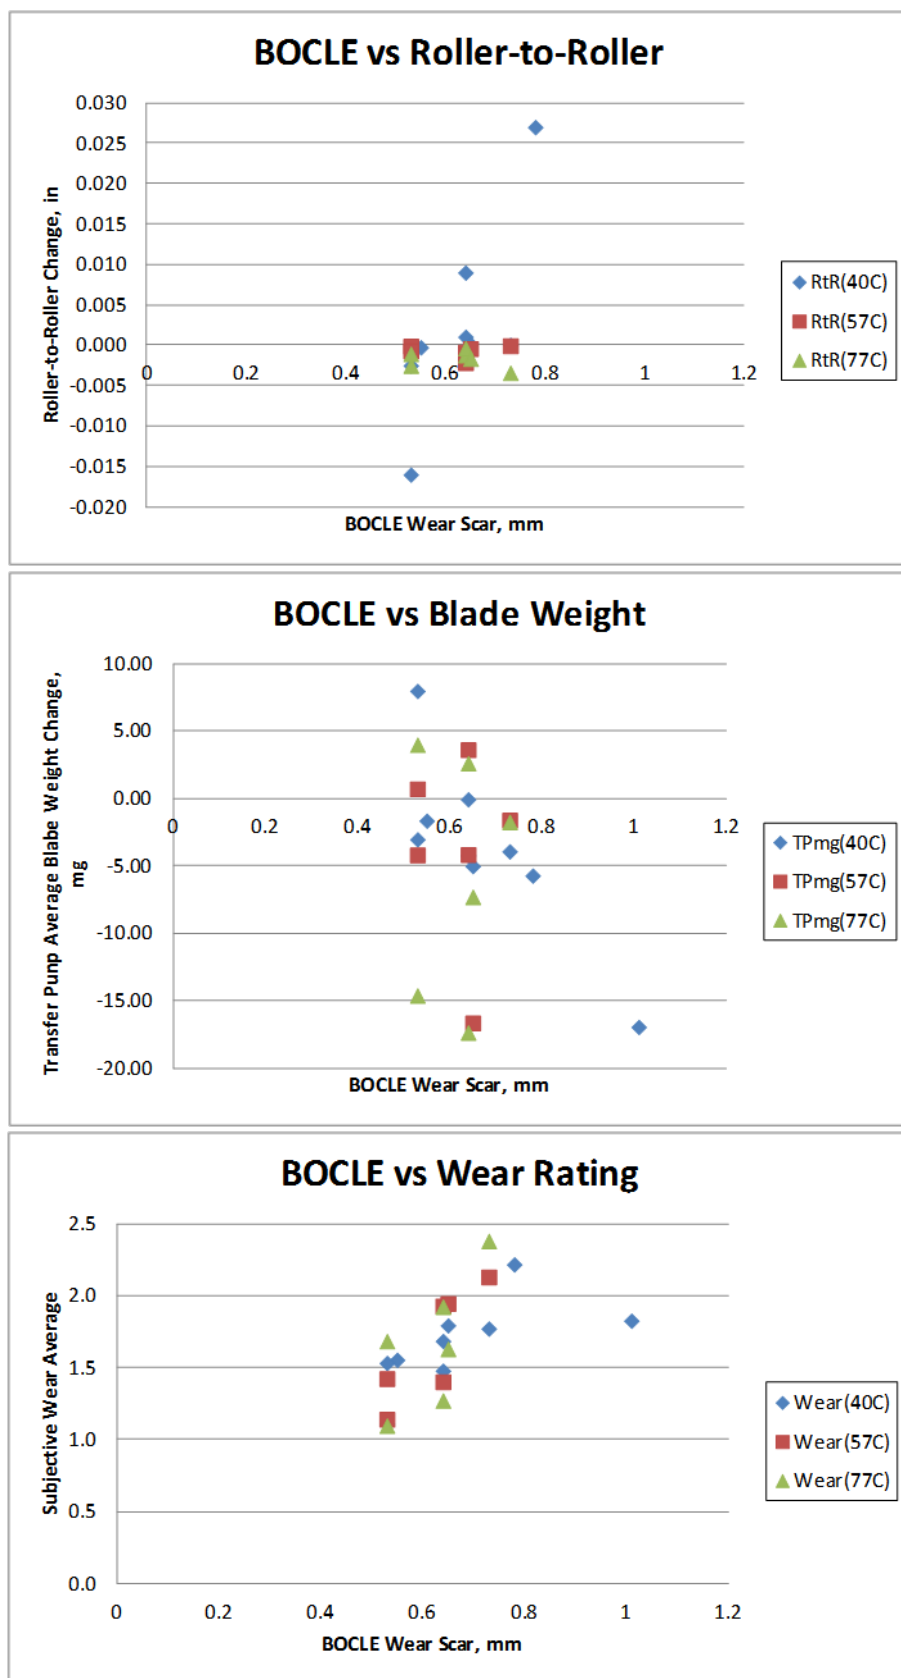
The fuel injection pump test stand wear assessment data for each test condition are plotted against the fuel lubricity bench test wear results. The ASTM D5001 BOCLE data for each test fuel is plotted against the three pump test wear criteria and presented in Figure 17. The pre-test BOCLE wear scar values are plotted in Figure 17 against the two pump average Roller-to-Roller dimension change, the eight blade average transfer pump blade weight change, and the two pump average subjective wear rating at each fuel inlet temperature. The Roller-to-Roller dimension change data at 40°C suggests that at increased BOCLE wear scars, low lubricity fuel, results in a larger dimensional change. The elevated temperature tests do not show the same relationship with the BOCLE data for Roller-to-Roller dimension change. The blade weight change comparison for the BOCLE data, although quite scattered does suggest that increased BOCLE values results in increased blade weight change. The 40°C data again appear to show a stronger trend with less scatter, due to more tests that were performed at 40°C. Of the three wear assessment variables in Figure 17, the subjective wear ratings appear to show a strong trend of increased wear rating with low lubricity fuels, larger BOCLE values, at all test temperatures.

Figure 17. BOCLE Wear Scar versus Wear Parameters and Fuel Temperature

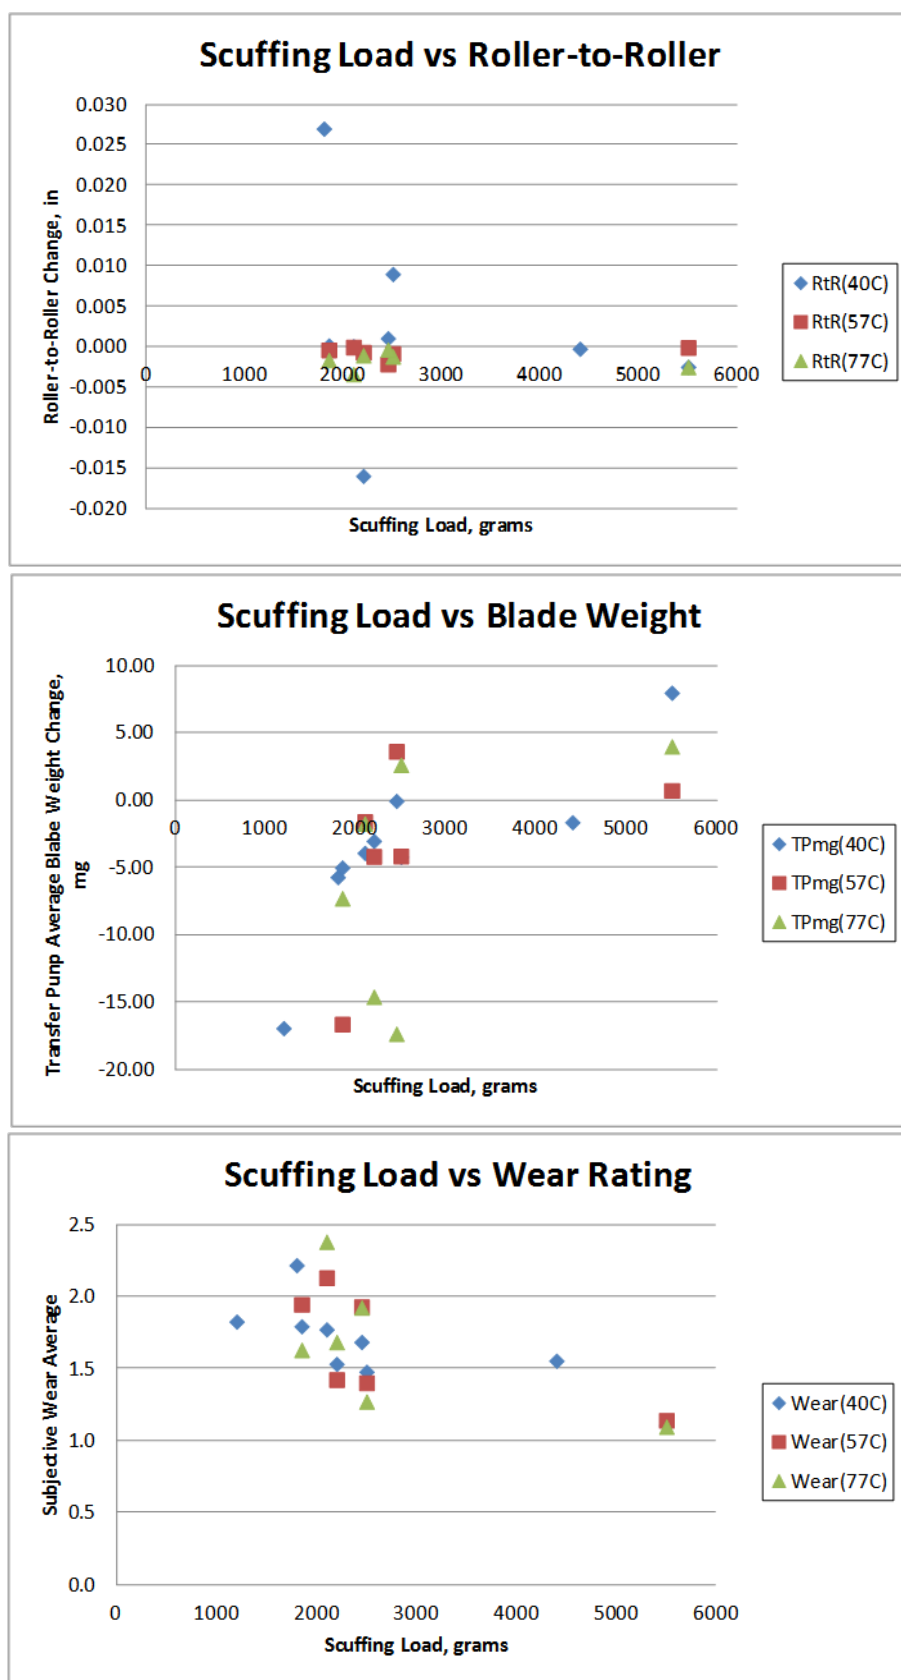
Figure 18. Scuffing Load versus Wear Parameter and Fuel Temperature

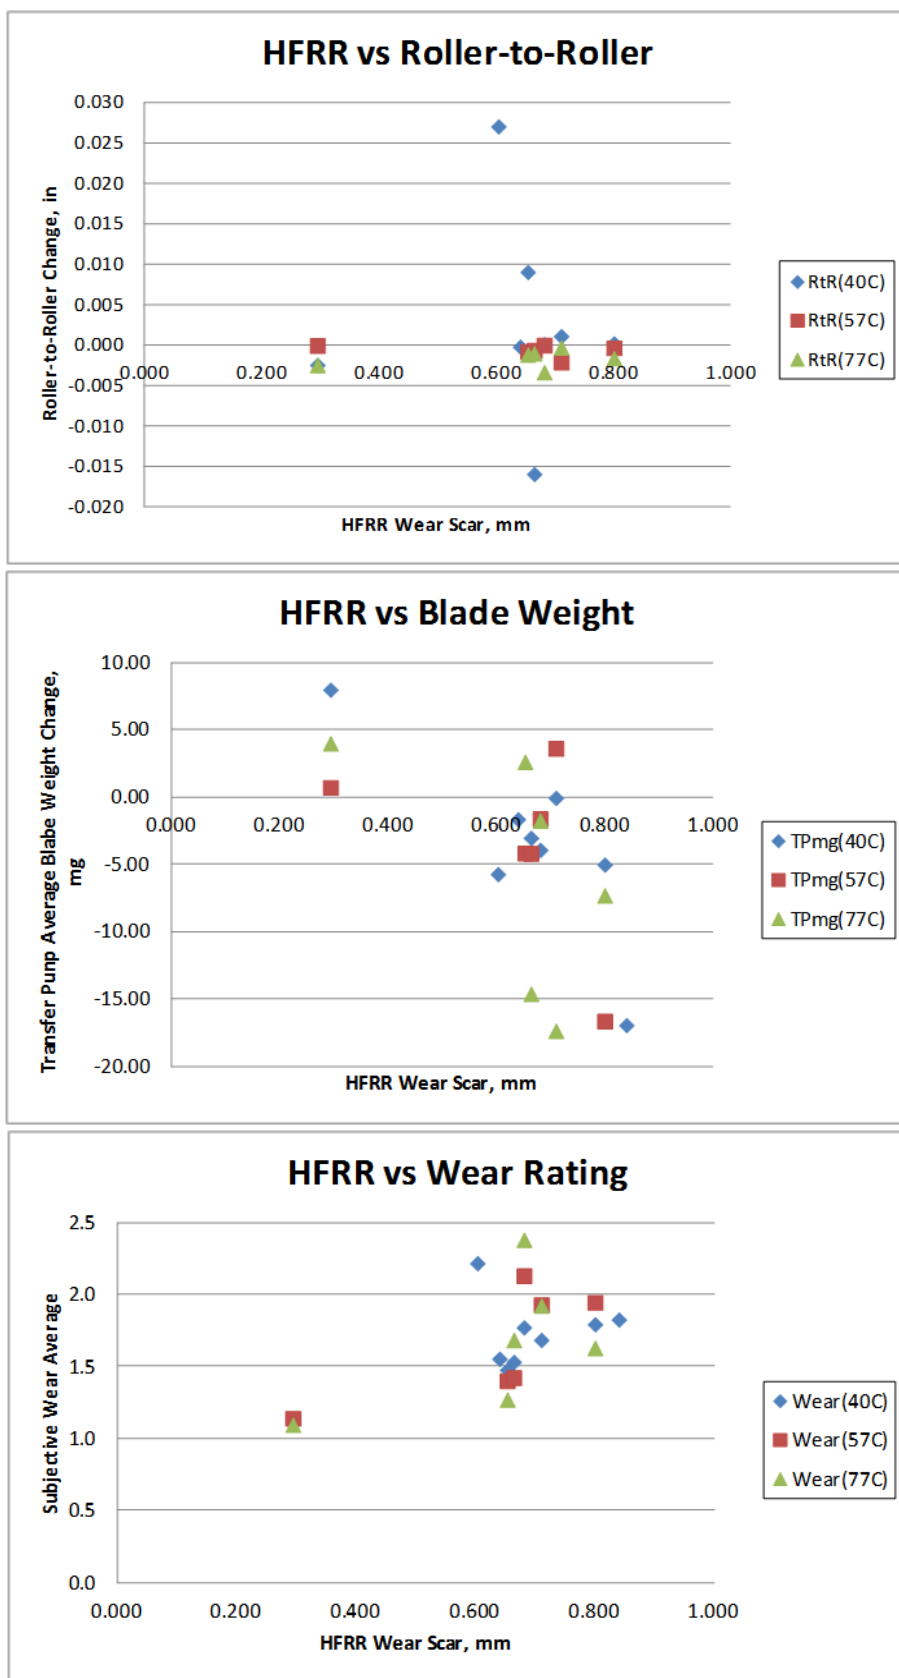
The ASTM D6078 HFRR fuel lubricity data for each test fuel are plotted against the three pump test wear criteria and presented in Figure 19. The pre-test HFRR wear scar values are plotted in Figure 19 against the two pump average Roller-to-Roller dimension change, the eight blade average transfer pump blade weight change, and the two pump average subjective wear rating at each fuel inlet temperature. The Roller-to-Roller dimension change data do not show a strong relationship with the HFRR wear scar data for any fuel temperature. The blade weight change comparison for the HFRR data, although quite scattered does suggest that increased HFRR wear scars result in increased blade weight change at all temperatures. The 40°C again appears to show a stronger trend with less scatter, due to more tests that were performed at 40°C. Of the three wear assessment variables in Figure 19, the subjective wear ratings appear to show a slight trend of increased wear with low lubricity fuels, larger HFRR values, at all test temperatures.
